51ST BRIGADE IRAQI ARMY BARRACKS
AL HILLAH, IRAQ

SIGIR PA-06-075
JANUARY 29, 2007

SUBJECT: Report on 51st Brigade Iraqi Army Barracks, Al Hillah, Iraq
(Report Number SIGIR PA-06-075)

51st Brigade Iraqi Army Barracks, Al Hillah, Iraq

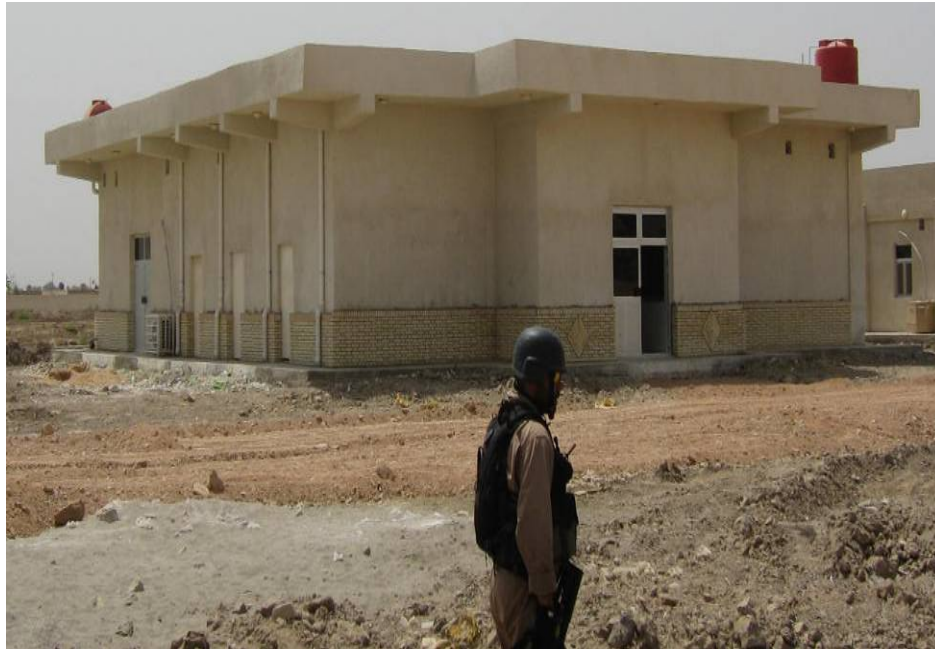
The dining facility floor plan included a 100-person dining room, a kitchen, a hand wash room, and three separate food storage rooms (dry storage, a chill box, and a frozen box). The design called for the base of the exterior walls to be covered with brick to a height of about 1 meter (m), and the upper portion of the walls covered with a ceramic type tile matt. Site Photo 1 shows the exterior of the dining facility. The contractor had constructed the brick facing along the bottom 1 m of the exterior; the upper portion of the walls were plastered, textured, and painted. We did not find any significant deficiencies with the exterior construction, except the top of the 1 m brick face on one side of the building. The contractor, on three sides of the building, had placed a ceramic tile cover over the top course of the brick face. However, on the front side of the building, the contractor had only placed a sand-cement topping, as shown in Site Photo 2. The USACE GRS Babil Resident Office PE informed us the contractor would make the necessary corrections.

Site Photo 1. Dining facility exterior

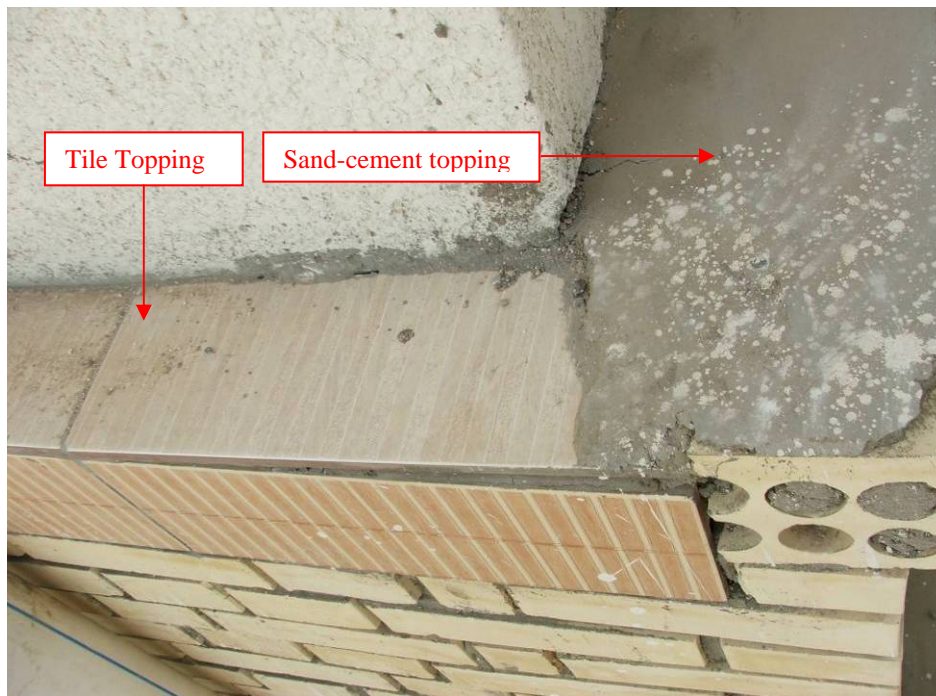
Site Photo 2. Brick face finish

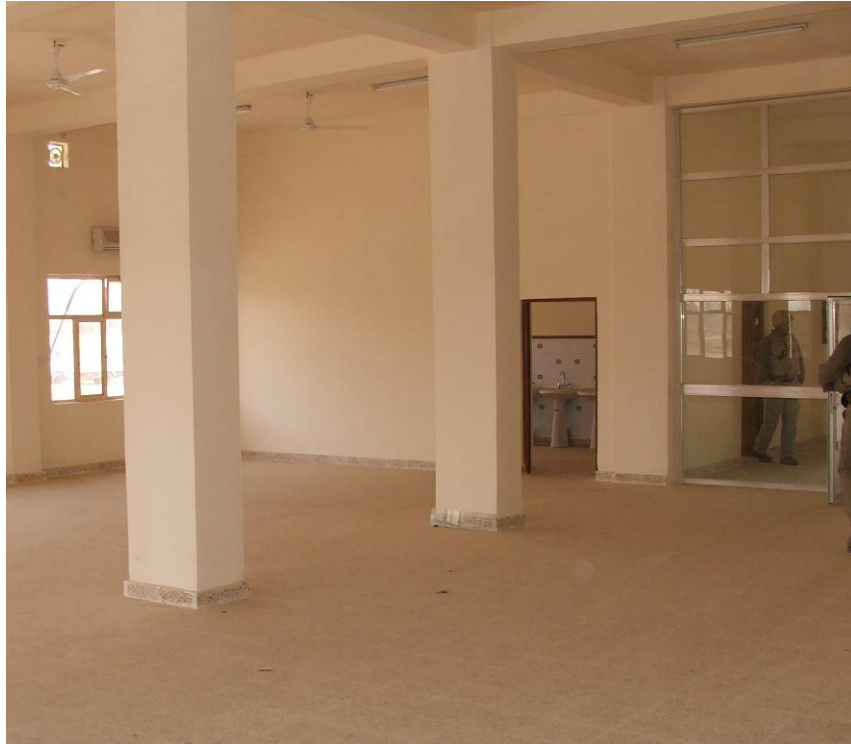
The interior walls of the dining facility were plastered and painted and the flooring included mosaic tiles. Site Photo 3 shows part of the interior finishes in the dining room.

Site Photo 3. Dining room interior

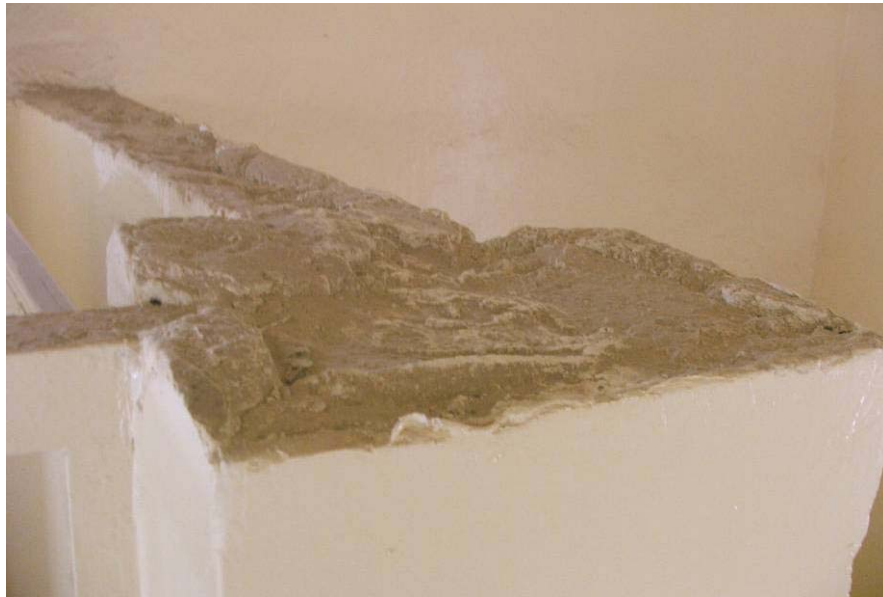
Although the walls and ceiling appeared to be finished properly, we did observe the top of the privacy walls constructed between showers and water closets were not finished in

the same manner as the walls and ceiling. The design contained no information regarding the finish requirements for the top of these walls. Site Photo 8 shows an example of the unfinished portion of the privacy walls. Aside from the ascetics, the rough surface will pose a problem for cleaning, and will trap moisture and dirt.

Site Photo 8. Top of privacy walls constructed in ablution buildings

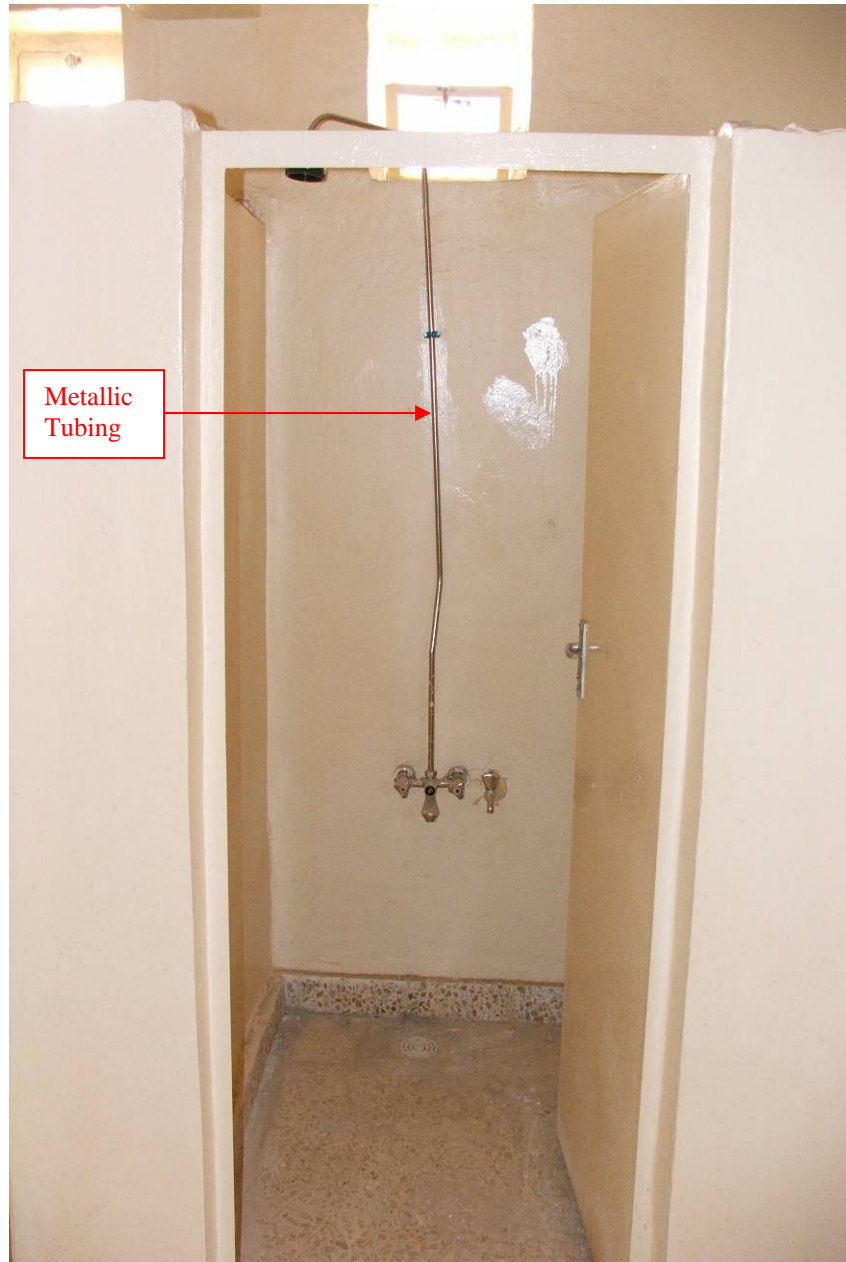
Regarding the plumbing fixtures used in the ablution buildings, we did observe what appeared to be low quality fixtures (shower heads, water supply lines, faucets, drain covers, etc.) installed in the showers, wash stations, and water closets. Site Photos 9 and 10 show the shower fixtures, including the shower head and the thin metallic tubing used to supply water to the shower head. Site Photos 11 and 12 show the type of plumbing materials used in the water closets, which includes flexible water hoses, plastic supply tanks, and thin wall plastic tubing supplying water from the tank to the toilet. Considering the ablution buildings will receive heavy usage, we believe the low quality plumbing fixtures will pose continual maintenance problems for the Iraqi Army.

Site Photo 9. Shower in ablution buildings

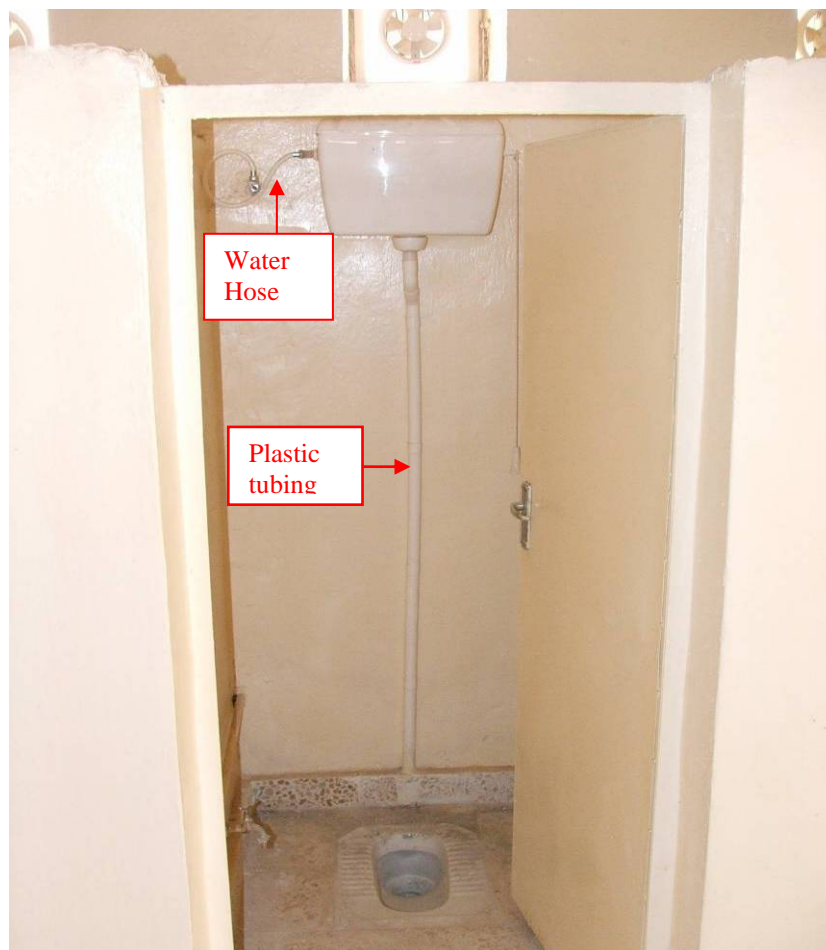
Site Photo 11. Water closet in ablution building

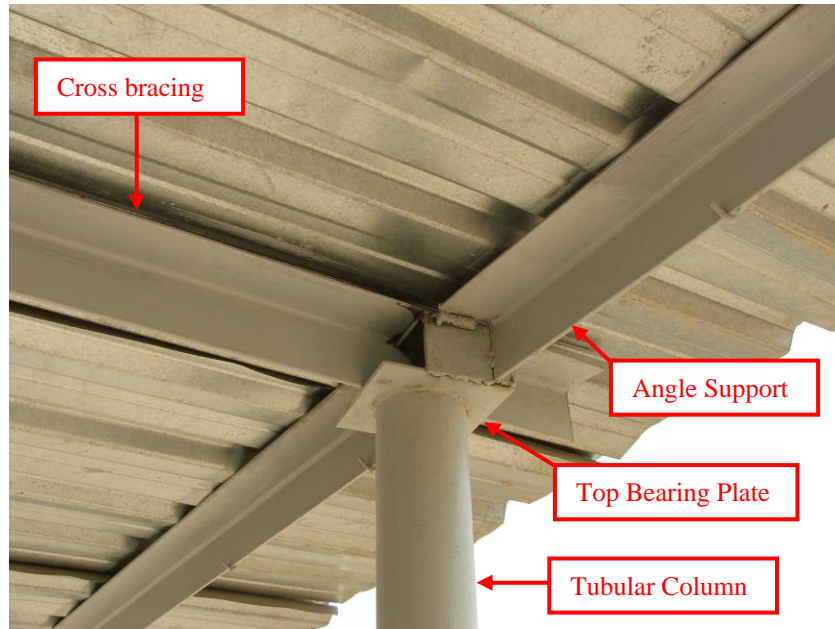
Site Photo 14 shows the actual welded angle connections at the bearing plate (i.e., shim plate) at the top of each tubular column, as well as, the lateral cross bracing. The roof sheeting material appeared to be a thin gage sheet metal, connected to the frame with J-bolts, as depicted in Figure 1.

Site Photo 14. Typical column support for covered parking (sunshade)

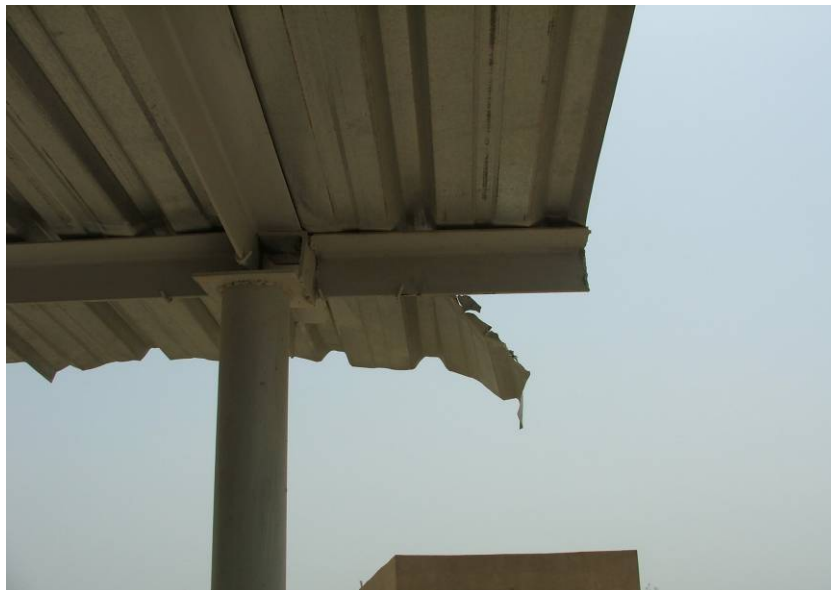
At one end of the sunshades, a portion of the metal sheeting was torn away at the corner (Site Photo 15). We also observed broken concrete at the base of one of the four inch tubular columns (Site Photo 16). Both of these items should be included in the punch list generated at final inspection.

Site Photo 15. Torn sheeting at one end of the parking sunshade

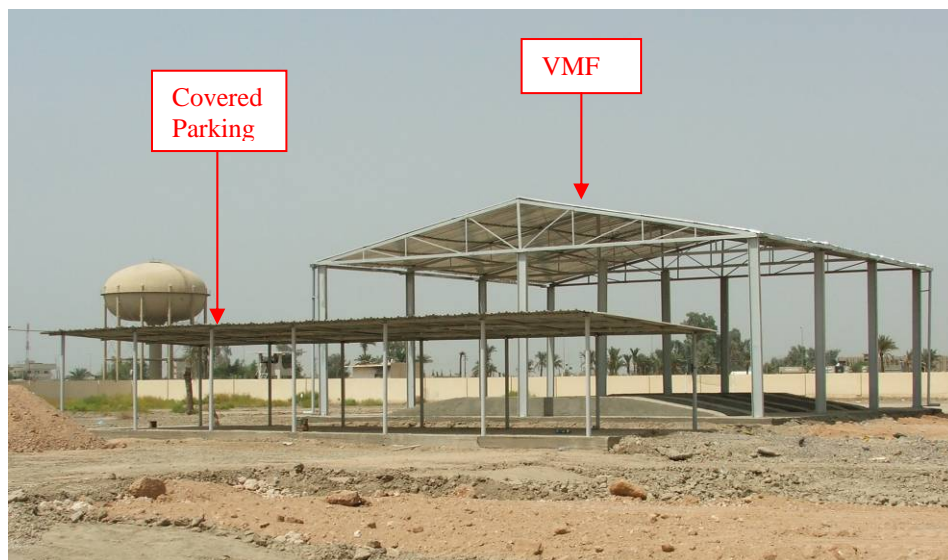
Site Photo 17. Vehicle maintenance facility (VMF) next to a covered parking sunshade

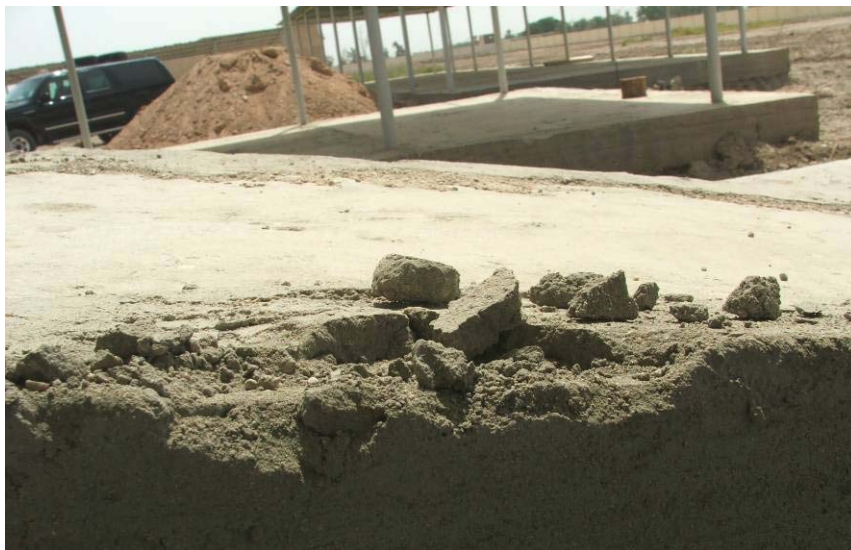
We also found the contractor had patched the ramp surface with a sand-cement mortar. There was no explanation for the need for patching; however, in several areas, the patch was crumbling. Site Photo 20 shows the crumbling material along the top of the ramp.

Site Photo 20. Crumbling mortar at the surface of the vehicle ramp

We recommend the Commanding General, Gulf Region Division, U.S. Army Corps of Engineers should assess the adequacy of the motor pool facility's concrete vehicle ramps and the structural steel frame supporting the roof.

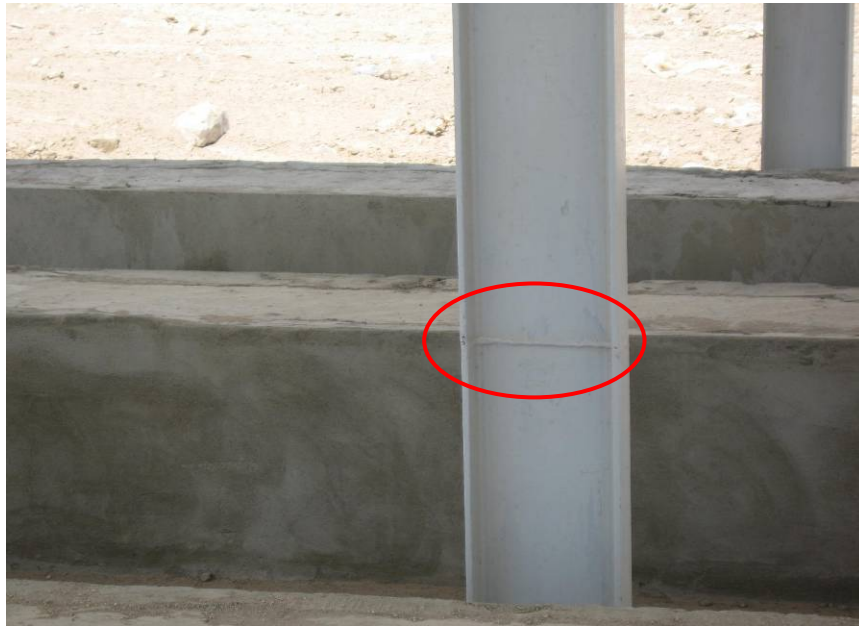
We also observed one of the H-columns consisted of two sections, butt welded together to form the column (Site Photo 21). In addition, in two of the 12 columns, we observed four bolt holes in the flange section of the column (Site Photo 22).

Site Photo 21. Spliced steel H-column at the motor pool

Our concerns about the motor pool noted above should be reviewed by a USACE GRS structural engineer, particularly since there were no structural design drawings for the facility.

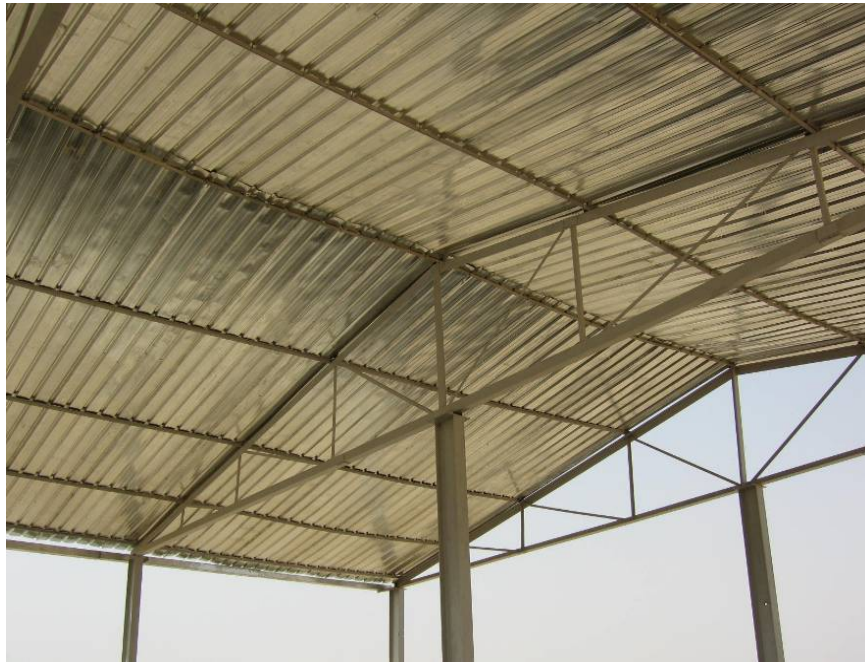
The motor pool's sheet metal roof was supported by four trusses consisting of steel angles. Each truss was supported by three H-columns, one at each end, and one at mid-span. Site Photo 23 shows two of the roof trusses.

Site Photo 23. Roof truss system supporting the motor pool roof

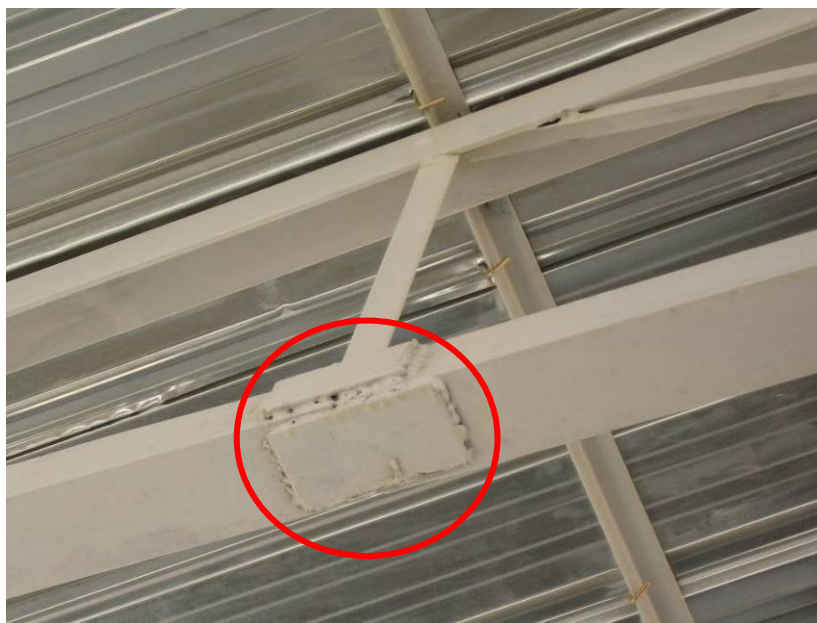
It appeared the roof trusses were adequately constructed; although we observed in several locations, the bottom chord of the truss was spliced between the columns. Site Photo 24 illustrates the spliced bottom chord. It appeared in these locations, the contractor welded plates to the bottom and side of the steel angle to stiffen the spliced connection.

Site Photo 24. Spliced bottom chord on motor pool roof

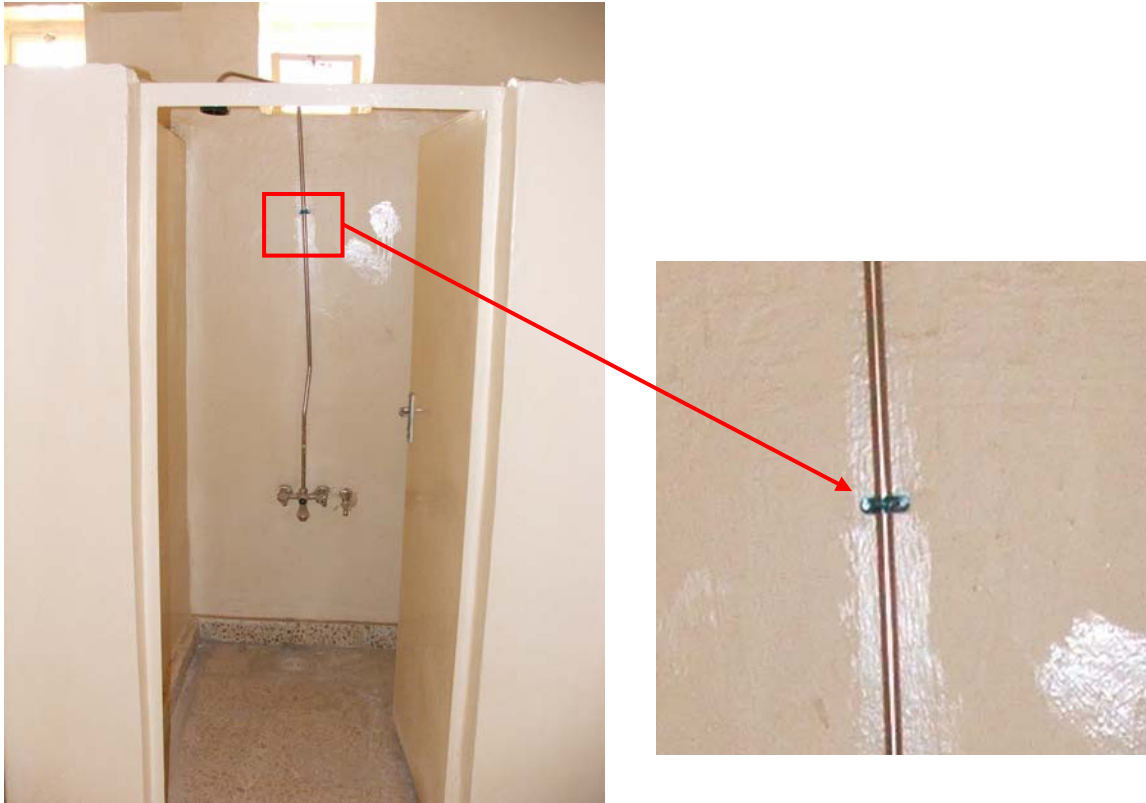
Earlier in this report, we identified potential sustainability issues with the low quality plumbing fixtures in the ablution buildings. For example, the plumbing materials used in the water closets were flexible water hoses, plastic supply tanks, and plastic tubing from the tank to the toilet; while in the showers, the water faucets are susceptible to breaking off and the thin metal water pipe to the shower head is connected to the wall with a one screw clamp (Site Photos 26 and 27). Over time, the clamp will dislodge from the wall and the shower water pipe will dangle. Considering the heavy usage the ablution buildings will receive, the low quality material will pose continual maintenance problems for the Iraqi Army.

Site Photos 26 and 27. Single screw clamp holding the thin metal water pipe to the wall.
